Vernacular Architecture Forum

1988 Annual Meeting Staunton, Virginia

FORT EGYPT, Page County

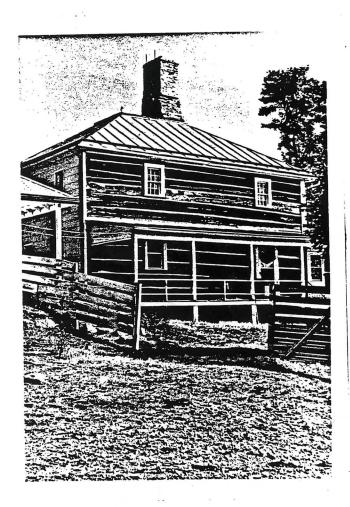
Fig. 4: Fort Egypt, south facade.
Photo by Dell Upton,
VHLC, 1978.

The original four-room form remains largely unaltered, although naturally the building has not been left alone the last two hundred years. Low horizontal windows were replaced with more conventional vertical sash windows during Federal-era remodeling, but the original two-bay arrangement of facade openings survives. This modest fenestration is somewhat surprising given the size of the house (36' x 32'2"). As expected in an Ernhaus or (probably less appropriately) Flurkuchenhaus, the off-centered door provides direct entry into a narrow Kuche, and the front window lights a square Stube, the chief entertaining room. As in most sizeable American <u>Ernhauser</u>, a narrow unheated chamber (<u>Kammer</u>) is located behind the <u>Stube</u>. A fourth room, perhaps a workroom, is partitioned from the rear of the Kuche and provided with a small fireplace. The semisubterranean ground floor is a classic example of a highquality German-American cellar with two insulated storage rooms, the inner one made superior by the use of a stone vault.

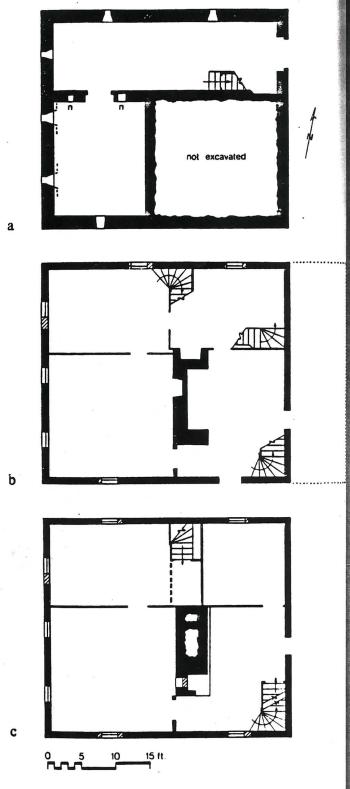
Fig. 5: Fort Egypt. Floorplans, top to bottom: cellar, main floor second floor. Drawings by Ed Chappell. Courtesy U. of GA. Press. Photo by Willie Graha CWF, 1987.

In the early 19th century, the interior was refined with board ceilings in three first-floor rooms, a new and cleaner partition between the <u>Stube</u> and <u>Kammer</u>, and a chair rail in the same three first-floor rooms and several second-floor rooms. Also, a rear stair was added, causing adjoining parts of the first-floor partition and upper flooring to be cut out.
